NPIC/R-294/63  
November 1963

PHOTOGRAPHIC INTERPRETATION REPORT

# HEN ROOST ANTENNAS ANTIMISSILE TEST CENTER SARY SHAGAN, USSR, JULY 1963

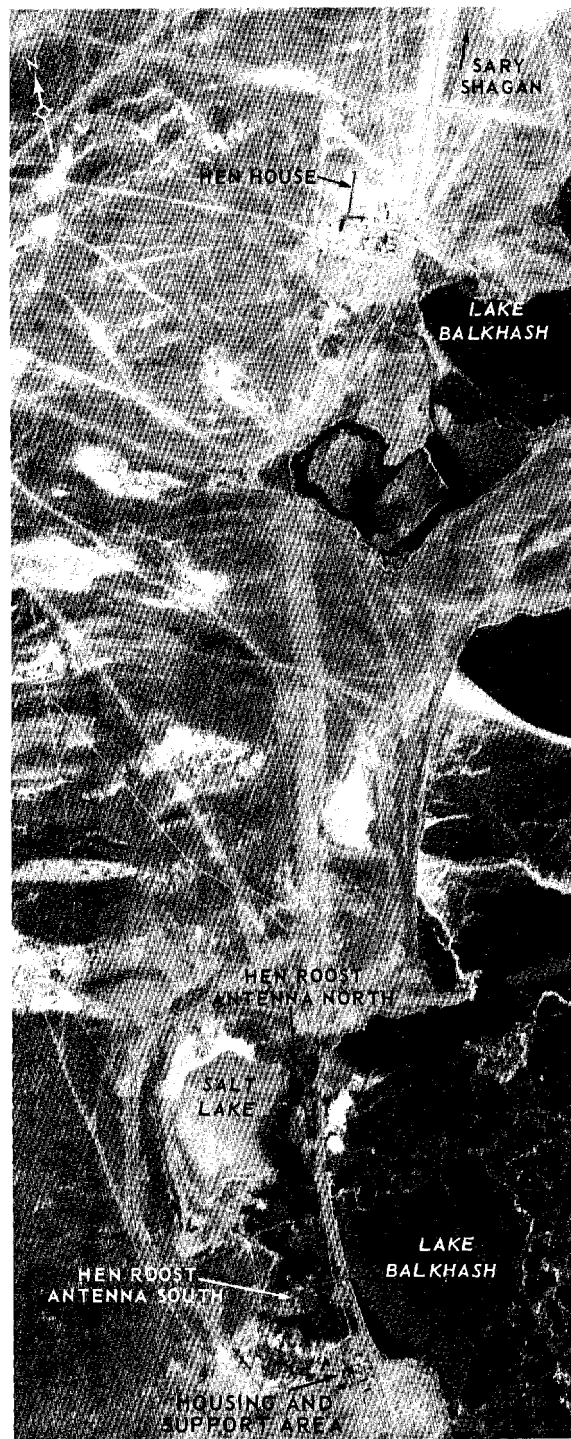
FIGURE 2. HEN HOUSE AND HEN ROOST ANTENNAS.

The reflector screen, clutter screen, and control building at HEN ROOST Antenna North do not appear to have changed from [ ] to [ ], as judged from current small-scale photography. A number of changes are apparent, however, in the smaller operational and support buildings at the site. From [ ] [ ] two small support buildings were dismantled and seven small buildings or objects (including three possible) were constructed. Additional activity was noted in [ ] when several sites east of the reflector screen were cleared of vegetation and two or possibly three small unidentified structures and one

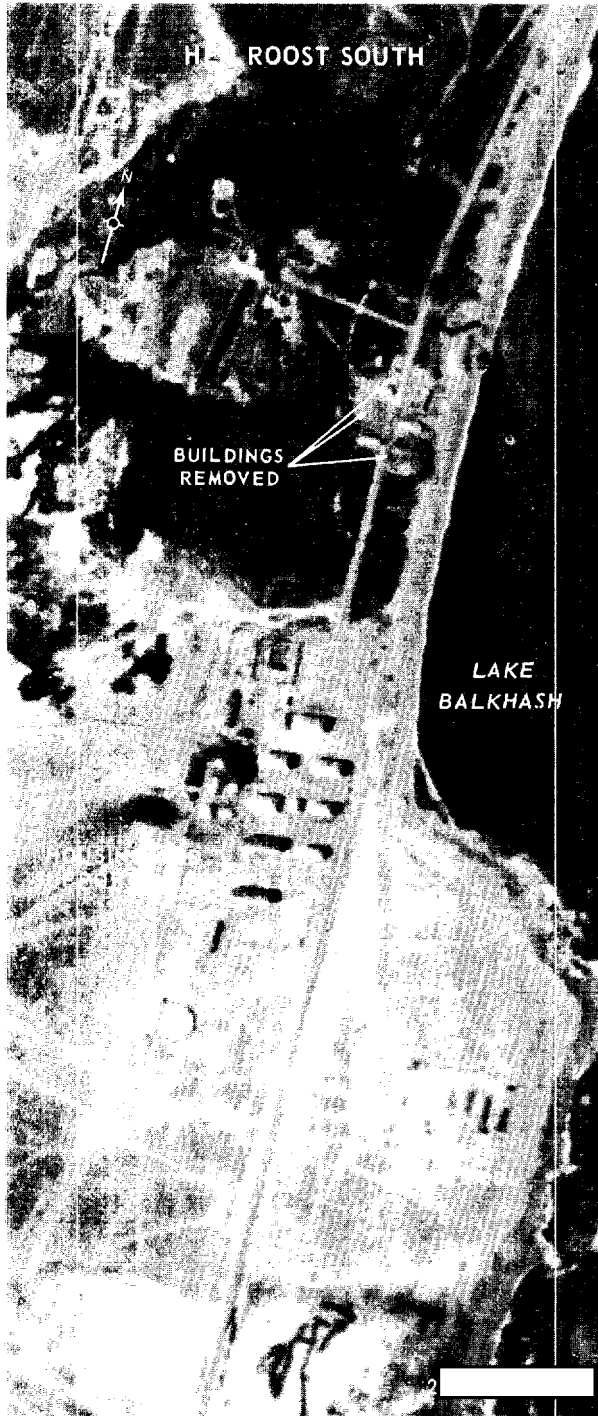
FIGURE 8. HEN ROOST ANTENNA SOUTH, AND HOUSING AND SUPPORT AREA. Changes indicated from [redacted]

Astride the main coastal road approximately 1,200 feet east of the possible reflector screen are approximately seven small buildings of various sizes, a probable pumphouse and a probable water standpipe. Three buildings appear to have been removed here between [redacted]
